STRUCTURE CONDITION REPORT

BARGE CANAL FAIRPORT-LOCK 33

STRUCTURE CONDITION REPORT
BARGE CANAL - WESTERN SECTION
FAIRPORT TO LOCK 33
P.I.N. 4940.29 - 101

AUGUST 1975

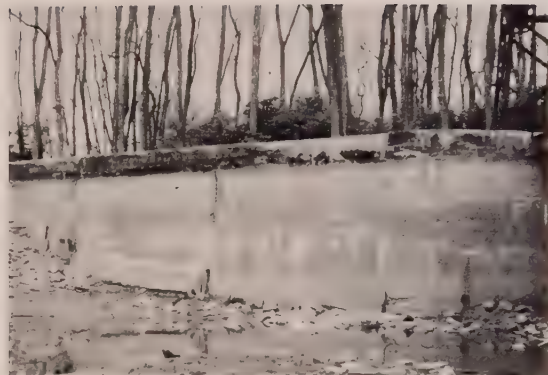
South abutment, east half

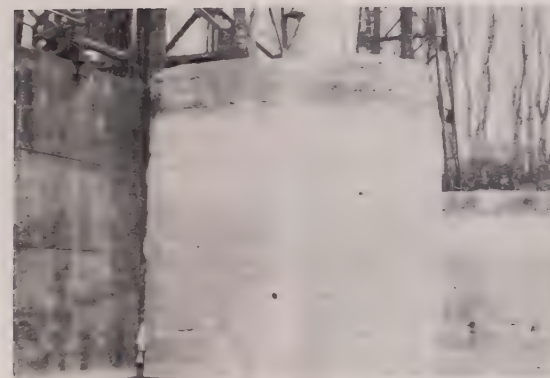
Future repair is also needed to the top of the center pier above the waterline where serious scaling and delamination have occurred.

Center pier, west side looking south;
Note core hole 5

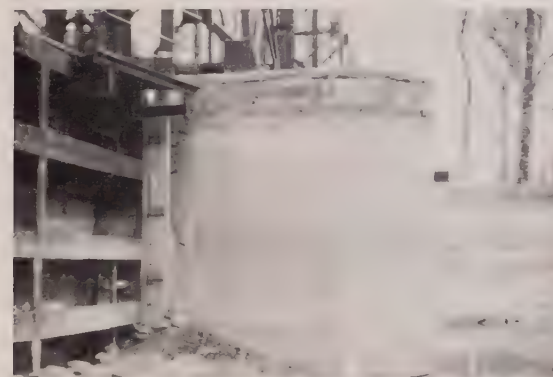
Center pier, east side, looking north

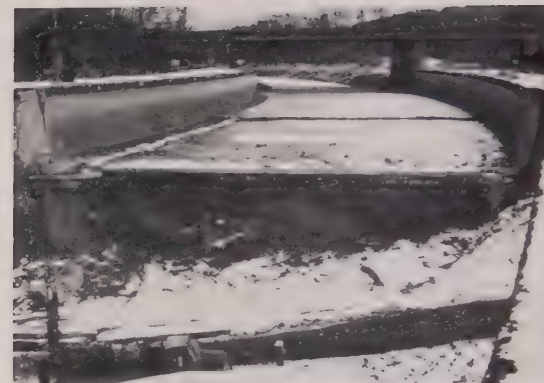
View of breach in trough, looking east
I-490 Bridge in background

On October 29, 1974, the concrete floor collapsed into a sewer tunnel being constructed under this section of the canal. The breach occurred near the center of the trough and left an approximate 95 foot by 100 foot hole in the floor. Both gravity walls remained intact after the breach although they had no bottom support for over 120 feet. This indicates the good condition of the concrete in these walls. Subsequently, 7 wall panels were removed from each side of the canal to permit repair of a 250 foot long section.

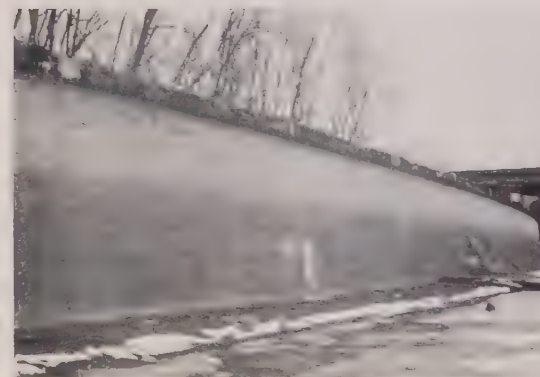
Of the 20 remaining wall panels on the north side of the canal, 14 panels exhibit little or no deterioration. Five panels show surface deterioration over approximately one half of their area and 1 panel exhibits surface deterioration over most of its area. Overall, approximately 15 per cent of the north wall area exhibits scaling and delaminations. Cores taken in these panels reveal that the majority of the deterioration only exists on the wall surface. However, scaling and cracking is common along the top of the walls above the normal waterline. This deterioration can be attributed to freeze-thaw cycles. Cores taken along the top of the wall reveal

North wall east of breach

that this deterioration extends into the wall to a depth of 10.5 inches.

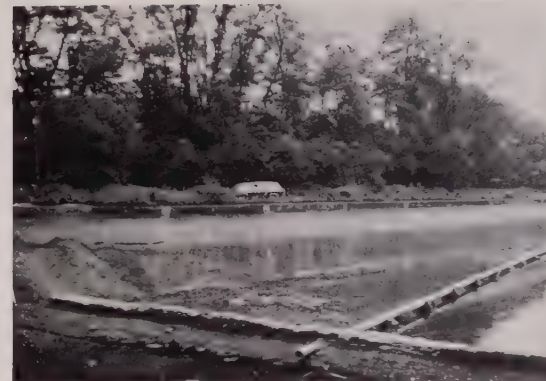
North wall west of breach

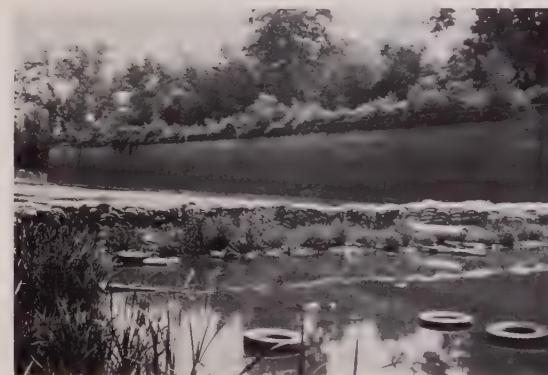
South wall west of breach

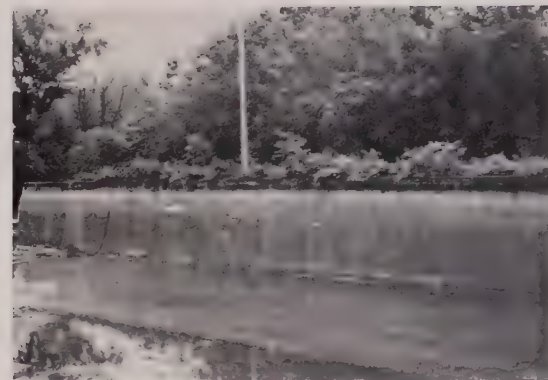
South wall west of breach

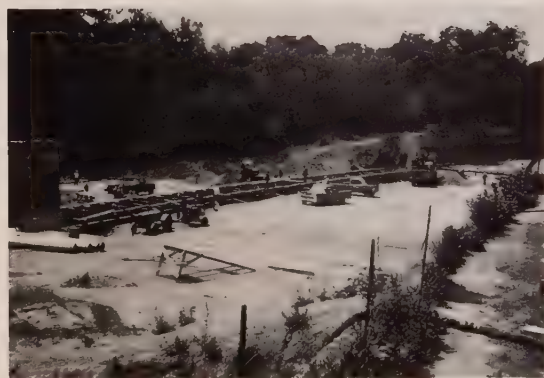
Repairs underway in breach

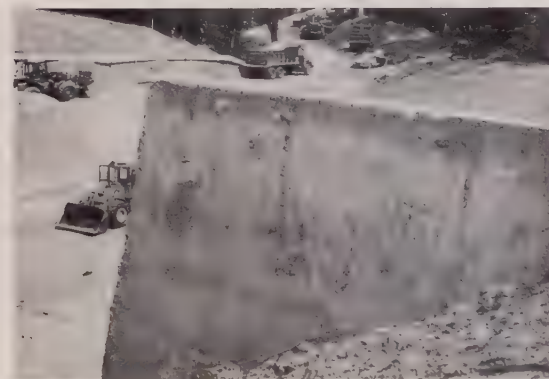
Exposed rear face of wall at breach

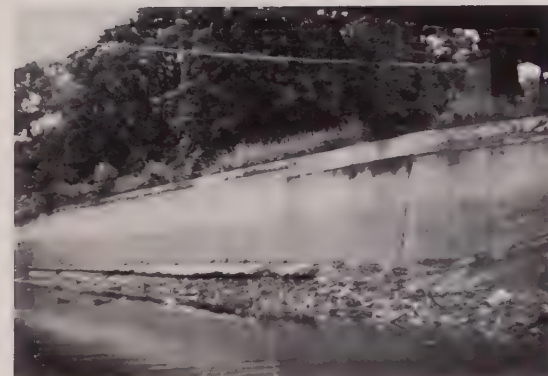
The 7 wall panels and the splay wall on the eastern end of the retaining wall are in good condition. Isolated areas of scaling and other deterioration is occurring in the top 2 feet of the wall which is above the normal water level. No delamination was detected by sounding the lower 6 feet of this wall section. Core #2, taken out of the 2nd panel from the east end, was in excellent condition and confirmed the soundings. This core had a compressive strength of 8,580 p.s.i.

East Section

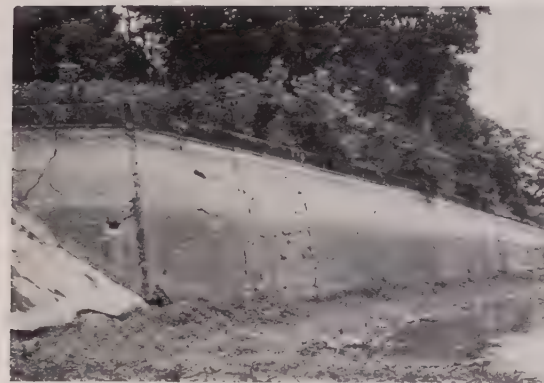
The western 9 wall panels and splay wall are distinctly different from the eastern section. The top 1 to 2 feet of these walls have been recapped with concrete and all these panels have been refaced

with an estimated 3 to 6 inches of concrete. Sounding revealed that this facing is loosely bonded to the original concrete wall. Core #1 contained a 4 inch section of refaced concrete, 3 inches of fractured concrete, and then 7 inches of concrete containing a few fracture planes. Based upon the condition of the lower portion of this core, we estimate that sound concrete would be reached approximately 6 inches further into the panel. Therefore, in the panel represented by Core #1, deteriorated concrete exists to a depth of approximately 20 inches. The total thickness of the panel in the area of Core #1 is 6 feet.

West Section

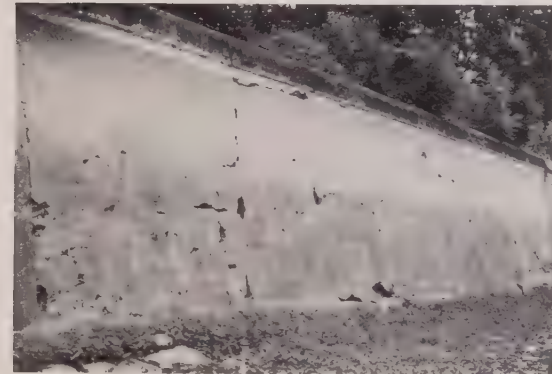
Middle Wall Panels, Note deterioration of refacing.

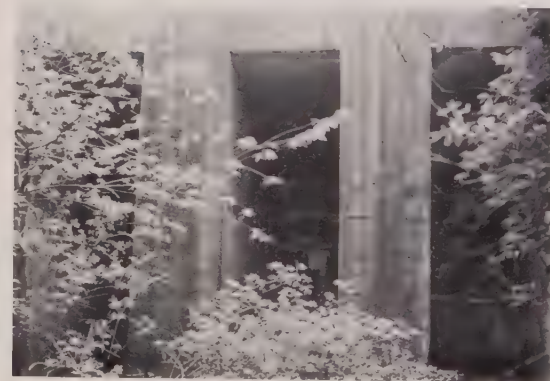
North side of Waste Gate

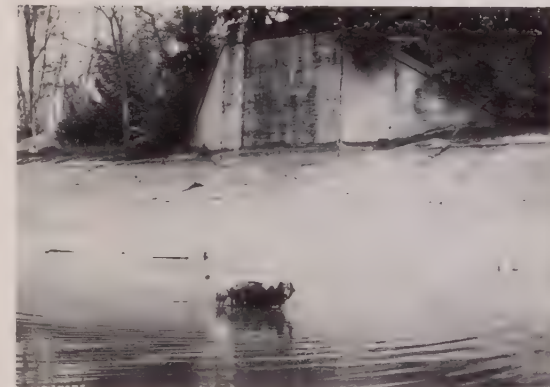
South side between Bushnell Basin Trough and Bushnell Basin Retaining Wall

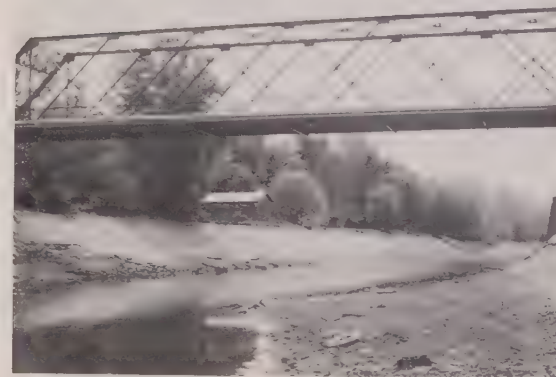
Lining between Bushnell Basin Trough and Bushnell Basin Retaining Wall, looking west. Note repaired lining on south side

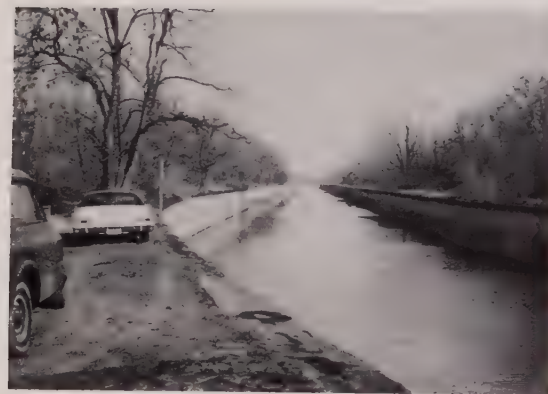
East end of trough looking west

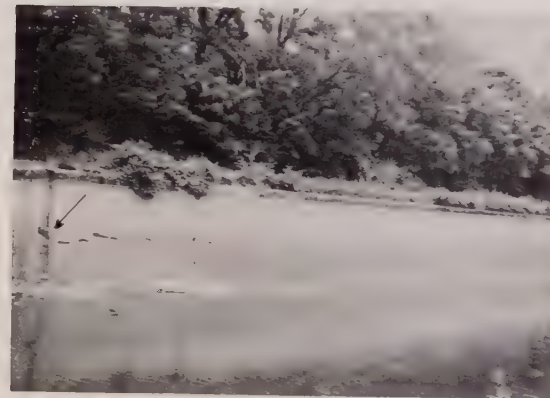
North wall panels 54-59 from east end,
note core hole 6

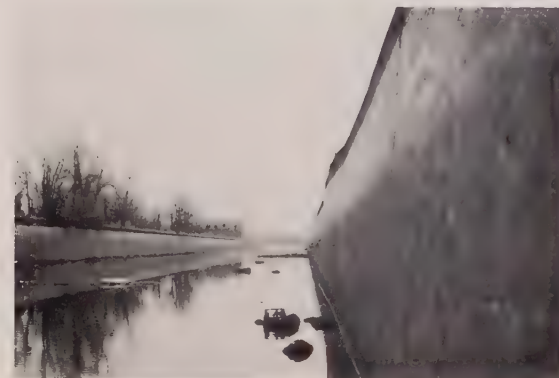
North wall near Core # 6; Note misalignment of wall that occurred during construction

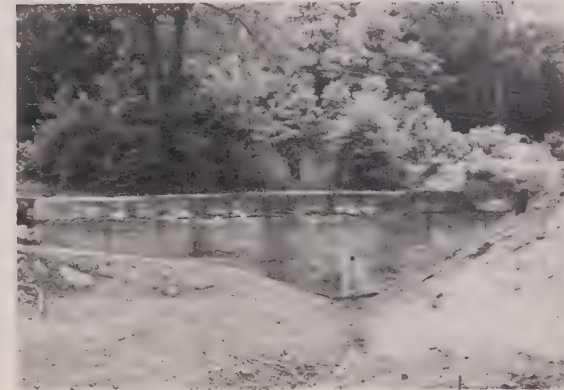
North east splay wall, Cartersville Guard Gate

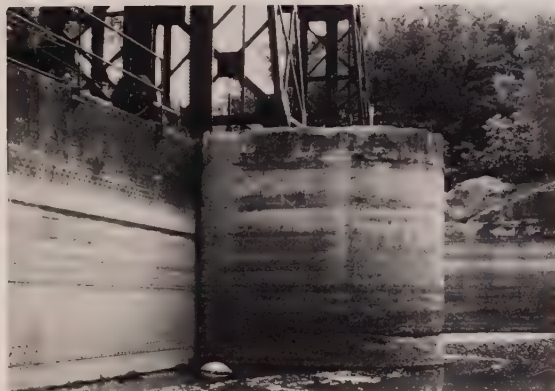
At the south abutment, the top 2 feet of the east splay wall sounded completely delaminated, while the remainder of the wall sounded in somewhat better condition. However, Core #2, taken from this area of the splay wall, revealed that the outermost 3 inches of concrete contained only a few small fracture planes while larger fracture planes existed to a depth of 11 inches into the wall.

South east splay wall, Cartersville Guard Gate

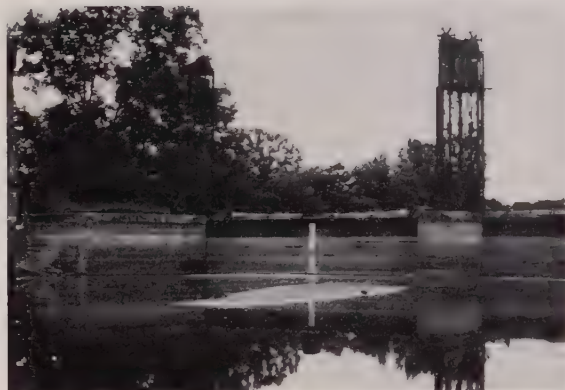
Center pier, north west section, Cartersville Guard Gate

over approximately 30 per cent of its lower vertical surface and the top 2 feet of the pier is delaminated. Core #3, taken down through the top of this pier, indicates deterioration over 26 inches deep. The lower portion of this Core #3 had a compressive strength of 4,800 p.s.i.

No immediate repairs are necessary at this time to maintain the stability of the structure. However, future repairs should include replacement of the concrete in the top 2 feet or more of the center pier.

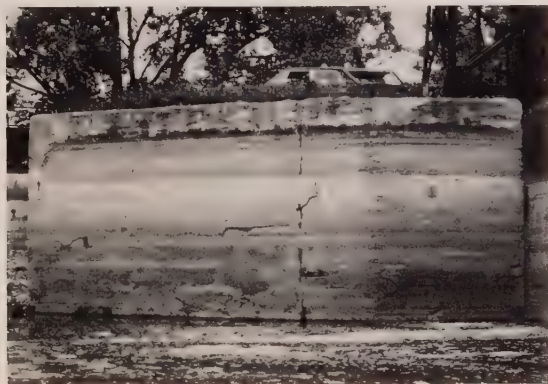
Cartersville Guard Gate, looking east

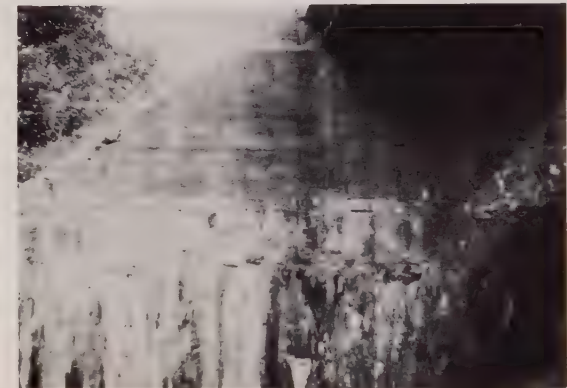
The concrete columns which support the tow path bridge are in very poor condition. Deep scaled areas exist on the lower portions of the columns and numerous cracks and efflorescence exist nearly everywhere else. The pier caps contain only two 1 inch square reinforcing bars while the four columns contain no steel reinforcement.

North side of Cartersville Weir and pier columns, looking east

The piers and pier caps supporting the tow path bridge are in poor condition. The concrete in these piers should be immediately repaired to insure support of this tow path bridge.

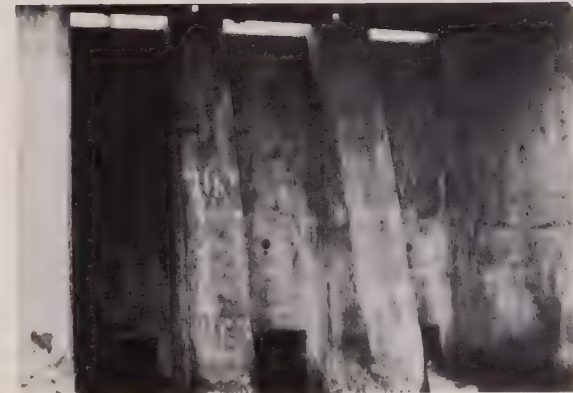
The waste gate exhibits scaling and delaminations over approximately 40 per cent of its surface area on the south or canal side. Core #1 obtained from the westernmost and least delaminated panel, contained fracture planes 13 inches in depth.

South side of Cartersville Waste Gate

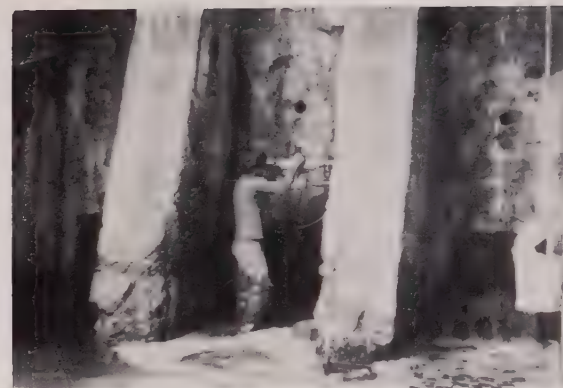
Shortly after the breach at Bushnell Basin, a temporary sand fill dam was placed across the canal adjacent to the east side of the gate as a result of a bomb threat. This prevented an inspection of about half of the concrete in the guard gate. The evaluation of this structure is based primarily on the condition of its west side and the similar condition of the Bushnell Basin Guard Gate.

Cartersville Guard Gate, looking west
Sand dam on east side

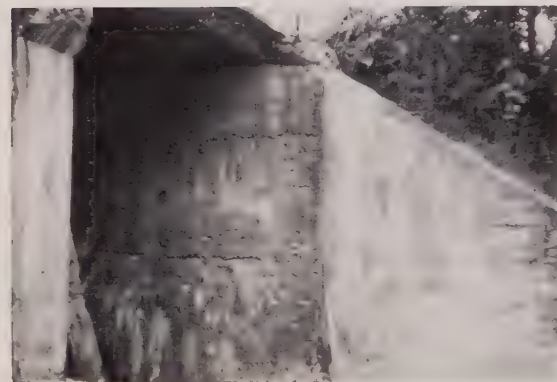
Coring north side of Cartersville Waste Gate

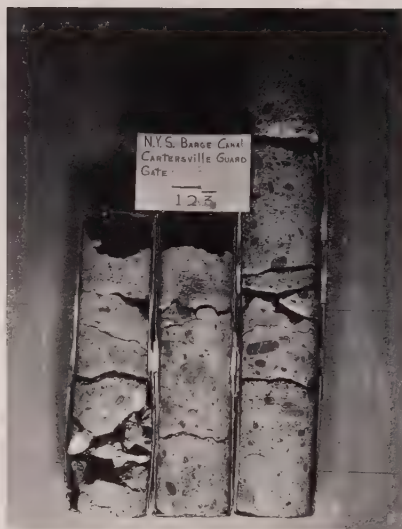
The west abutment, which forms part of the wall for the waste gate, initially appeared to be in much better condition, but sounding

indicated that delaminations begin approximately 3 feet above the bottom. However, the adjacent section of sloping wall was sounded and was found to be in very good condition. A section of Core # 4 from deep inside the weir had a compressive strength of 5100 p.s.i.

West Abutment of Cartersville Waste Gate
and Tow Path Bridge

The concrete in the western abutment and the eastern buttress wall (adjacent to the waste weir) also contains areas of deterioration and will require repair in the near future.

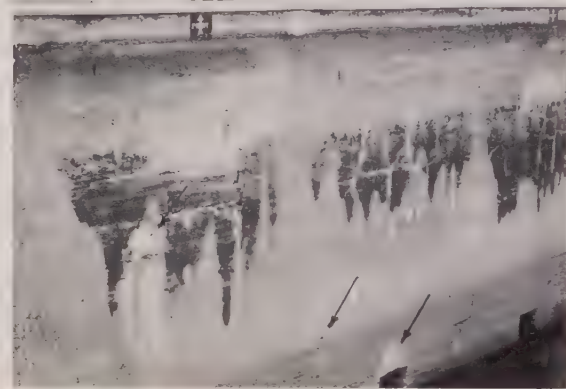
The north lock chamber wall presently contains scaling, cracks and delaminated concrete on over 90 per cent of its surface. Of the 13 wall panels between the gates, 11 have deterioration over all of their surface area and 2 panels have deterioration over approximately one half of their surface. Overall, an estimated 30 per cent of this north lock wall was refaced with shotcrete. Areas of shotcrete range from none on 4 panels to approximately 80 per cent on the panel adjacent to the west gate. The 7 cores obtained from this wall (Cores # 6-12) revealed that deterioration

North lock wall, core holes 9, 10, and 11, from left to right

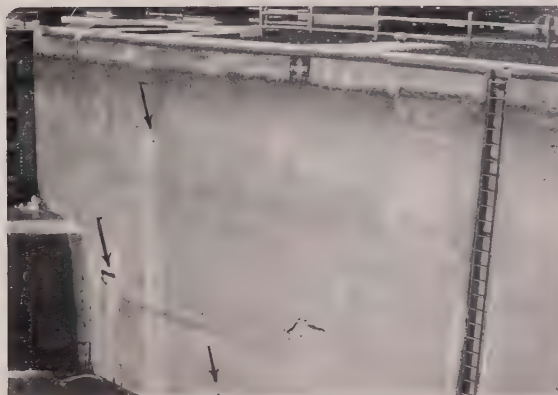
North lock wall, core holes 6, 7, and 8, from left to right

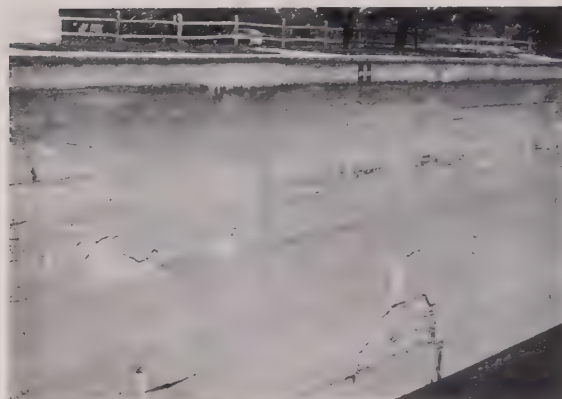
North lock wall, middle section

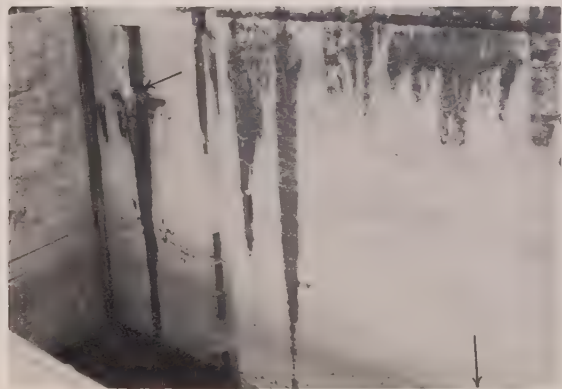
South lock wall, core holes 19 and 18, from left to right

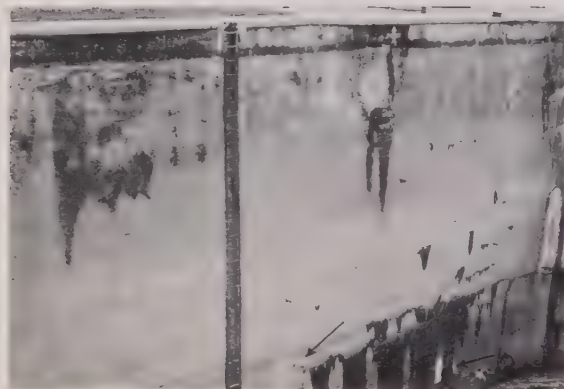
South lock wall, core hole 14 and 13, from left to right

The south lock chamber wall has scaling, cracks and delaminated concrete over an estimated 50 per cent of its surface. Of the 13 panels, 4 show deterioration over most of their surface, 7 exhibit deterioration on one-half of their area, and 2 show little or no deterioration. Approximately 80 per cent of the south lock chamber wall has been refaced with shotcrete, which was 3 to 4 inches in thickness as noted in the cores. The 7 cores from this wall (Cores #13-19) showed that deterioration generally ranged from 6 to 18 inches in depth. Core #15 had a compressive strength of 6,940 p.s.i.

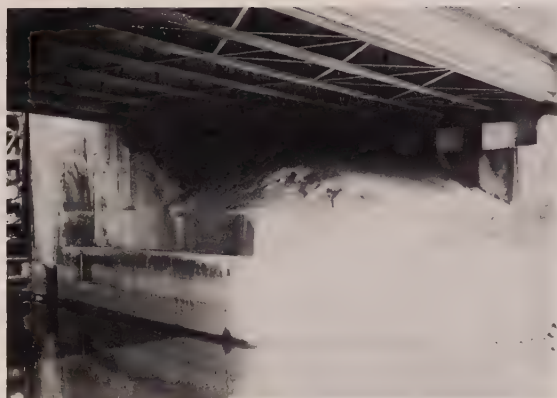
North east guide wall and Route 65 bridge

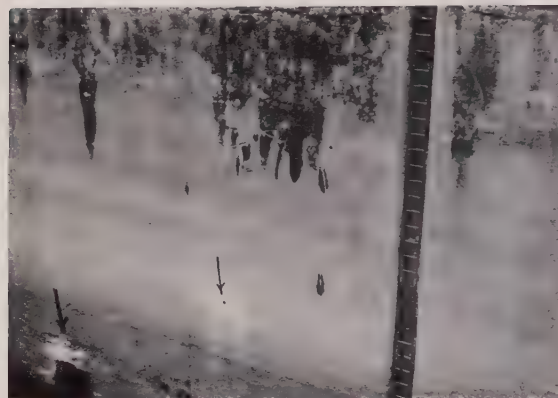
South lock wall, core holes 17 and 16 from left to right

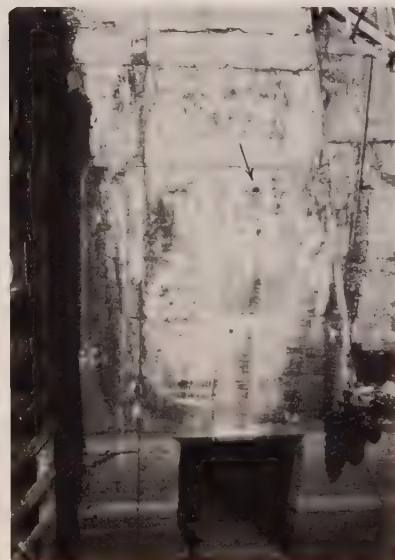
North main culvert discharge, note core hole 5

Deterioration inside the main culverts is very limited. Scaling up to 5 inches deep was noted in a few areas of the floor and lower culvert walls. Ground water leaks through the vertical construction joints when the lock is empty of water and some of these joint edges are scaled. Delaminated concrete was detected near the lock ends of the ports, but few areas of delaminated concrete were detected in the culverts. Overall, the main culverts, except for the entrance areas adjacent to the upper gates, are presently in good condition.

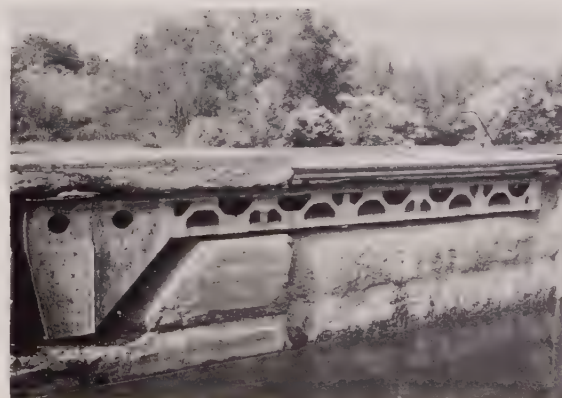
Extensive concrete deterioration was noted around the area of the eastern buffer beam on the lower guide wall. Overall, the surface area of the lower guide wall was estimated to be 50 per cent scaled

Buffer beam and guide wall, west end

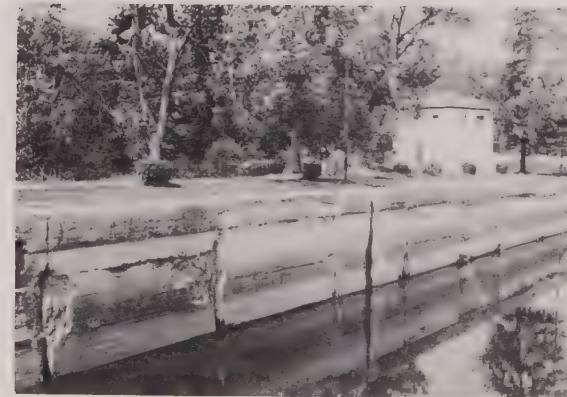
The upper guide wall has delamination and deep scaling over nearly all of its surface. Cores #1 and 2 were taken in this wall from locations approximately 200 feet west of the upper gate. Core #1, from an area of deep scaling, showed that deterioration extends 16 inches in from the original surface. Core #2, from an adjacent area which appeared to be in better condition, contained deterioration 7 inches in depth. The lower portion of Core #2 had a compressive strength of 5390 p.s.i.

West guide wall; white building in background is the powerhouse

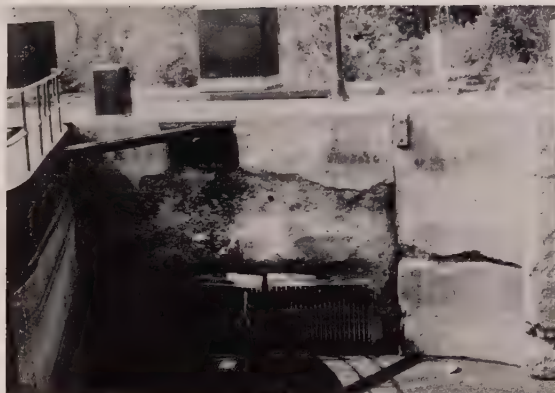
In the vicinity of the entrances of the main culverts, adjacent to the upper gates, the concrete is extensively scaled and delaminated similar to the condition found in Lock 32. Core #3, from over the south entrance, revealed that deterioration in this area extended over 4 feet into the wall. This deep deterioration most likely resulted from drainage down through the floor of the machinery pits located directly above this core location. Core #4, from the same area on the north wall, contained deterioration only 17 inches in depth.

South main culvert intake and trash racks, note
core hole 3

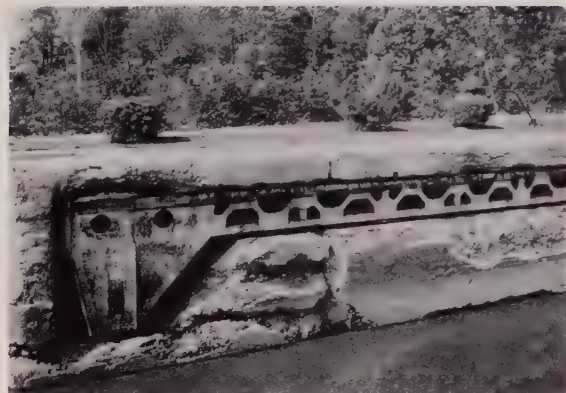
West guide wall and buffer beam

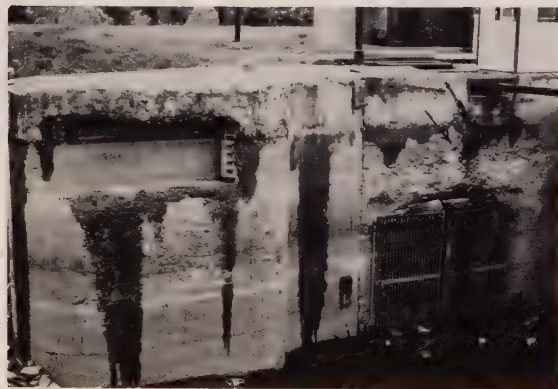
North main culvert intake and trash racks, north
west approach wall, note core hole 4

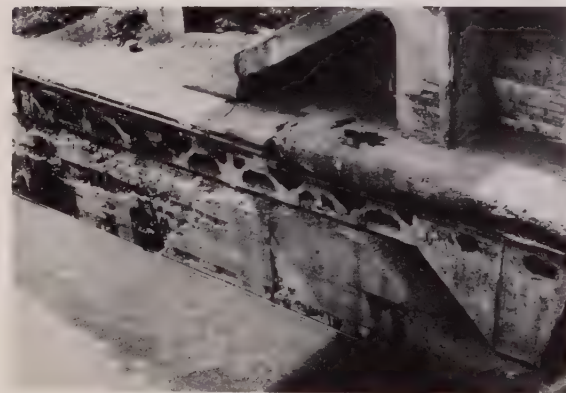
East guide wall and buffer beam

The lower guide wall is extensively scaled and deteriorated around the area of the east buffer beam. Similar deterioration exists around the area of the west buffer beam and both buffer beams at Lock 32. Overall, the lower guide wall was estimated to be 50 per cent scaled and delaminated with the major portion of the deterioration located on the upper section of the wall. An old pedestrian bridge at the east end of this wall is severely

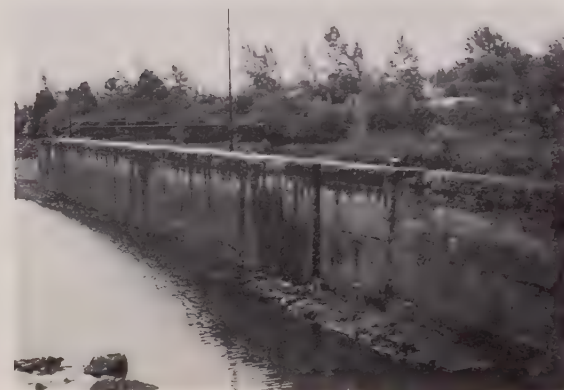
East guide wall, looking south

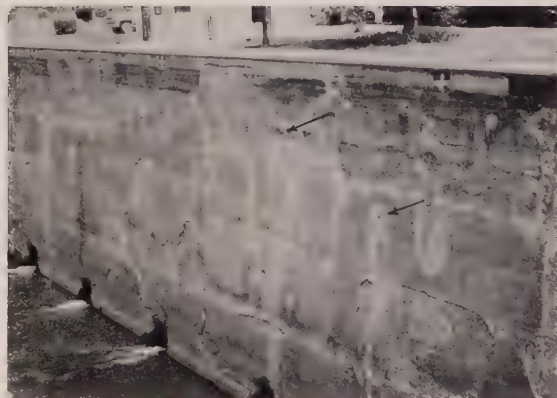
The north lock chamber wall contains deterioration over nearly all of its surface. Cores #12-21 revealed that this deterioration generally extends from 5 to 14 inches in depth from the original surface. Three of these cores (#13, 14, and 15) were taken from areas of deep scale below the top of the wall, near vertical construction joints, where the concrete surface appeared to be continuously wet. These cores showed that deteriorated concrete extends into the wall for a depth of up to 2 feet in the vicinity of these joints. Groundwater appears to be slowly seeping through these joints, as was also noted in the lock culverts, and staining the wall as it drains into the lock. Core #17 had a compressive strength of 6,300 p.s.i.

North lock wall, core holes 16 and 17, left to right

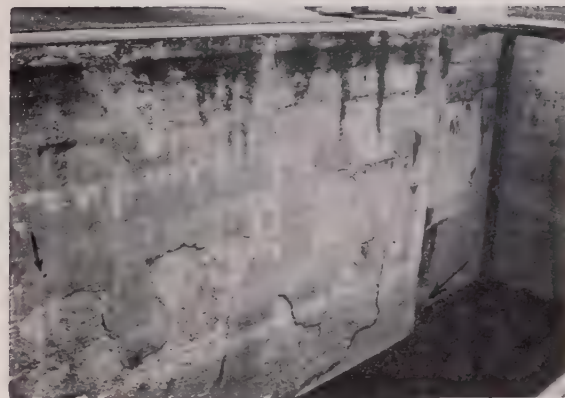
North lock wall, core holes 20 and 21, left to right

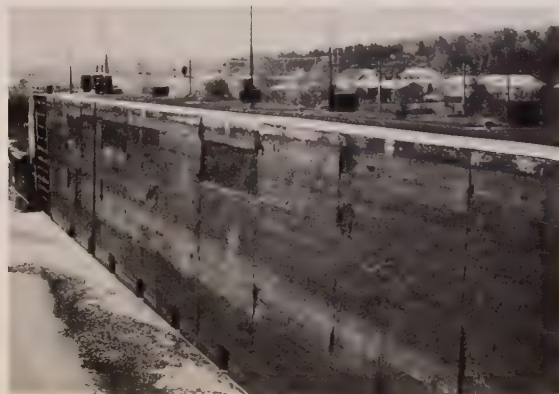
The south lock chamber wall has scaling and delamination over an estimated 60 per cent of its surface. Cores #7, 8, 10 and 11 contained deteriorated concrete from 5 to 14 inches in depth. Soundings along the lower 6 feet of this wall indicated that portions of these wall sections were in relatively good condition. Core #9, which was taken in one of these good sections, contained no deterioration and had a compressive strength of 6930 p.s.i.

Overall view of south lock wall

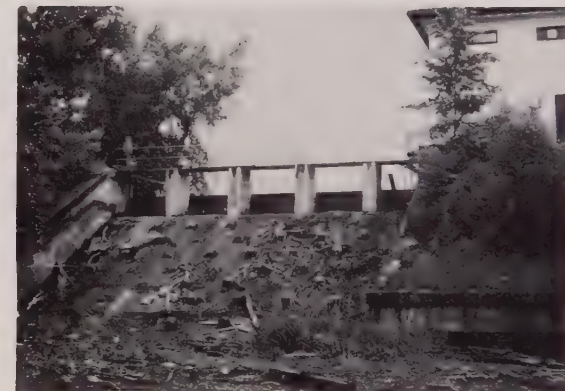
Spillway tailrace and powerhouse discharge
